Facility Condition Assessment

Orland Park Public Library
14921 South Ravinia Avenue
Orland Park, Cook County, Illinois 60462

AEI Project No. 468087
Site Assessment Date: September 2, 2022

Subject: Facility Condition Assessment
Orland Park Public Library
14921 South Ravinia Avenue
Orland Park, Illinois 60462
AEI Project No. 468087

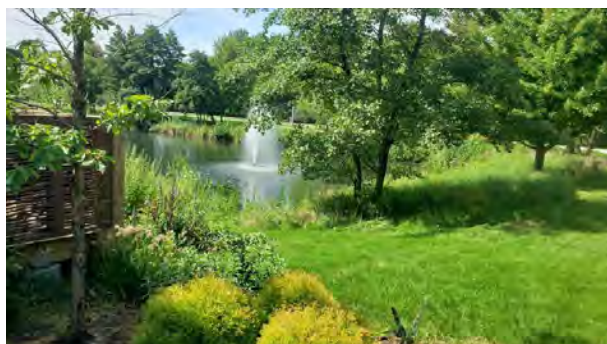
Routine maintenance of the drainage systems is expected to be adequate to maintain the drainage systems and components in good condition during the projection period covered by this report.

On-site retention pond.

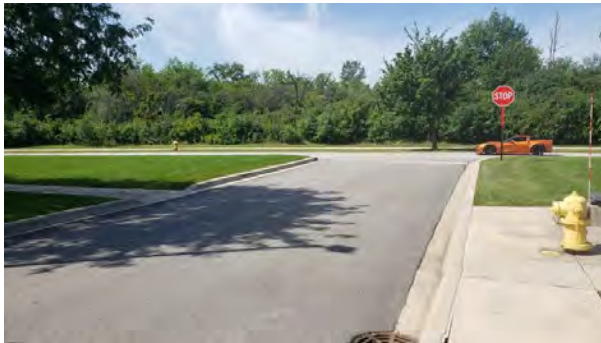
Concrete paving is utilized at the porte cochere drop-off drive. There are no significant signs of cracks or surface deterioration. Routine maintenance is expected to be adequate to maintain the concrete pavement systems in good condition during the projection period covered by this report.

Primary entry drive.

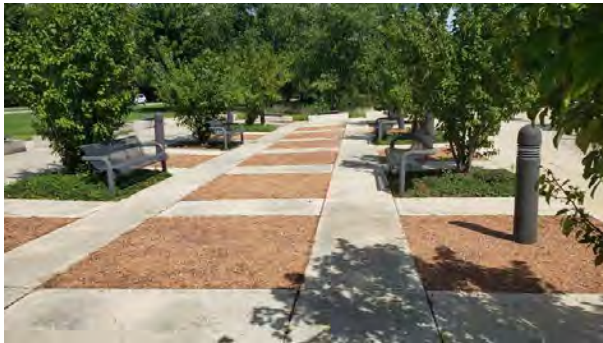
Routine maintenance is expected to be adequate to maintain exterior pedestrian walkways and curbing in good condition during the projection period covered by this report.

Concrete and brick pedestrian paving.

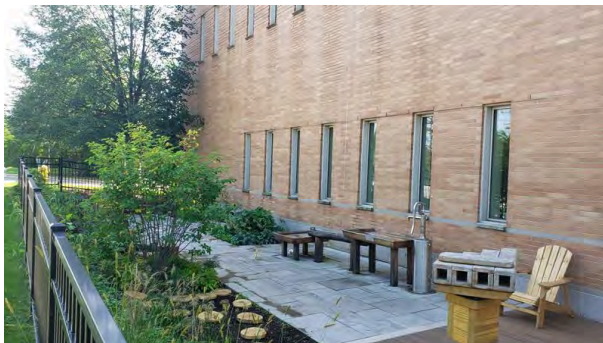
The site amenities were observed to be in good condition. Painting of the benches is anticipated during the term, but can be accomplished as part of routine maintenance due to the nominal cost. Routine maintenance is expected to be adequate to maintain the site amenities in good condition during the projection period covered by this report.

Childrens outdoor play area.

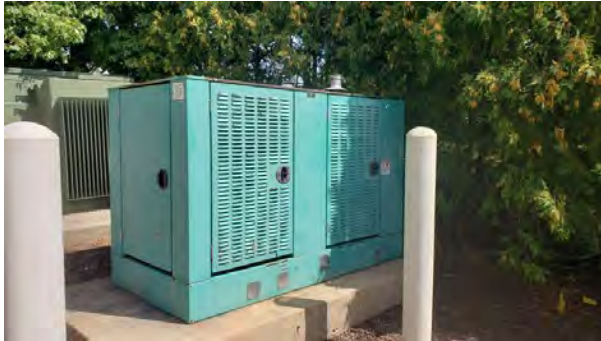
Emergency generators typically have a useful life of 20 to 30 years depending on weathering, usage, and maintenance practices. Based on the estimated age of the system, planning for replacement of the generator set and transfer switch is recommended late during the term. An allowance for this work is included in the Tables.

The emergency generator.

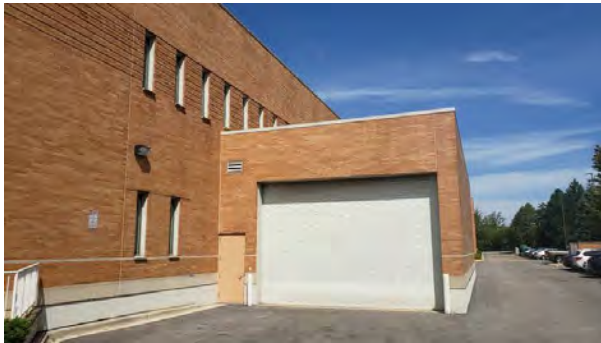
No unusual problems or concerns were observed or reported with the maintenance garage or porte cochere. Routine maintenance is expected to be adequate to maintain the maintenance garage and porte cochere good condition during the projection period covered by this report. Systems such as roofing, cladding, and doors are discussed in other Sections of this Report.

The service garage.

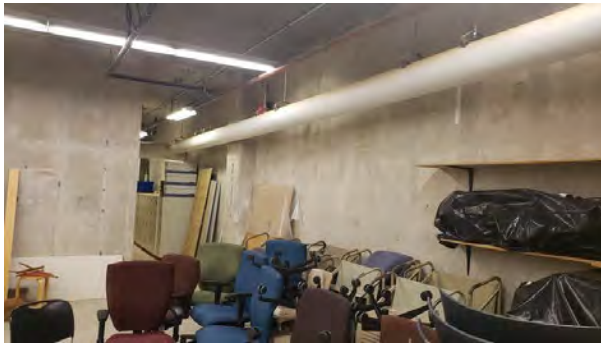
The substructure is considered to be generally adequate and in overall good condition. The foundation system appears to be providing satisfactory support for the above grade structure. No unusual problems or concerns were reported or observed.

Basement concrete foundation walls.

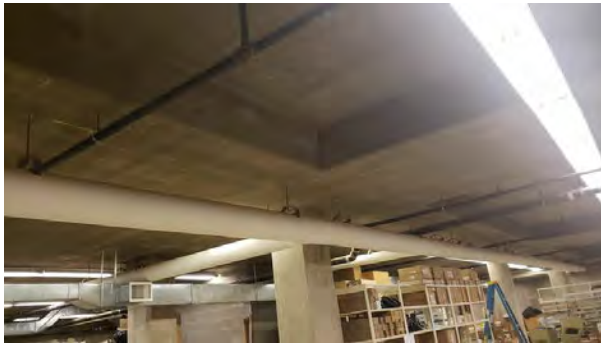
The structural system appears to be providing effective support for the building envelope and interior floors. No unusual problems or concerns were reported or observed pertaining to the superstructure.

Concrete framing.

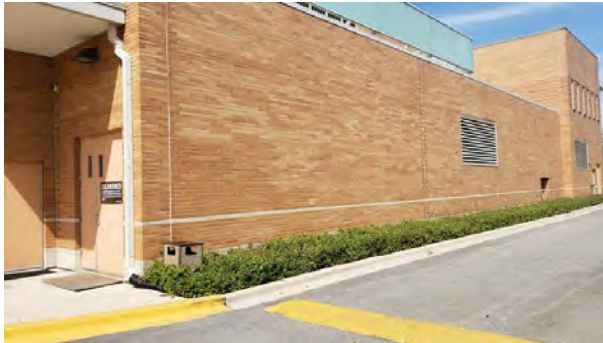
Prolonged exposure to sunlight and moisture can cause the sealants to shrink and crack, decreasing the protective properties of the sealants. Overall, sealants were observed in fair condition except around the windows at the lower mechanical roof along the east elevation, at which localized loose or missing caulking was observed. Repairs are recommended accordingly. An opinion of cost for this work is included in the Tables.

Typical brick cladding.

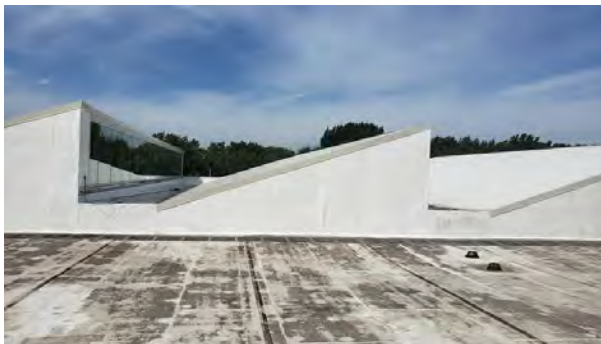
Newer TPO roof on sawtooth skylights.

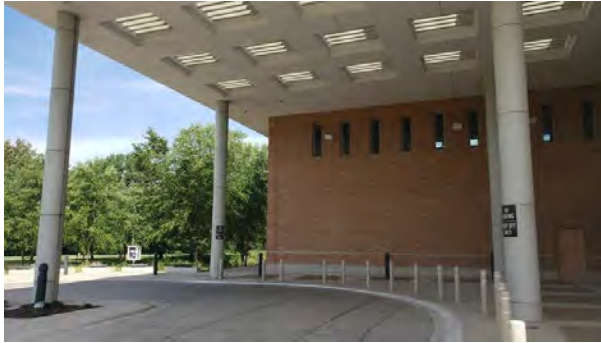
door systems. Based on the age, condition, and expected useful life, routine maintenance is expected to be adequate to maintain the door systems in good condition during the projection period covered by this report.

Punched window openings.

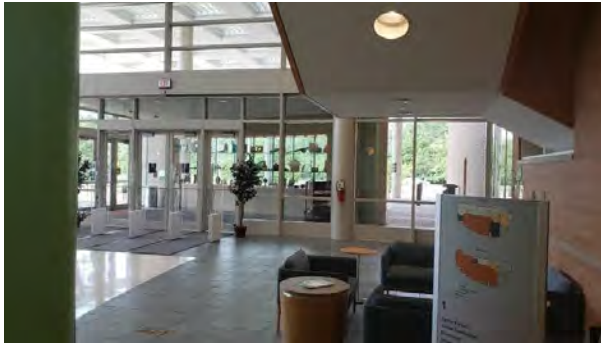
Lobby finishes.

AEI recommends reserve funding, during the evaluation period, for replacement of the carpeted flooring. An opinion of cost for this work is included in the Tables.

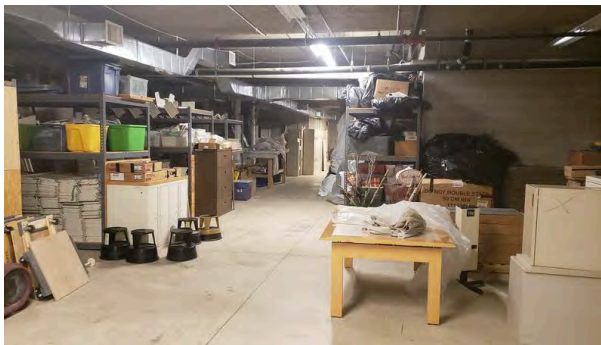
Routine maintenance is expected to be adequate to maintain the remaining non-public area finishes in good condition during the projection period covered by this report.

Interiors-Basement storage.

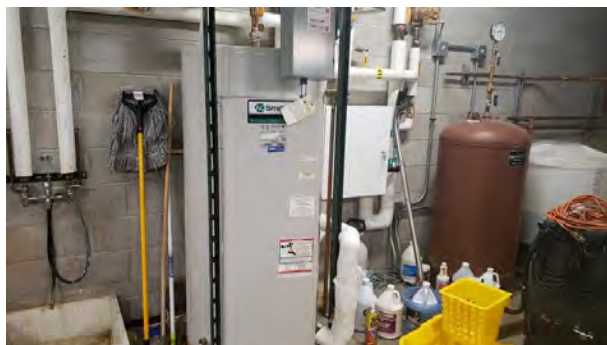
Domestic hot water is provided via a circulation loop from the HVAC boiler system. Hot water is stored for in-demand use in a 119-gallon storage vessel with electric re-heat. The unit was installed in 2014 and appears to be in good overall condition. Storage vessels of this type typically have a useful life of 20+ years depending on quality of water, usage, and maintenance. Based on the observed conditions and age of the equipment, significant replacement is not anticipated during the term.

Common electric water heater.

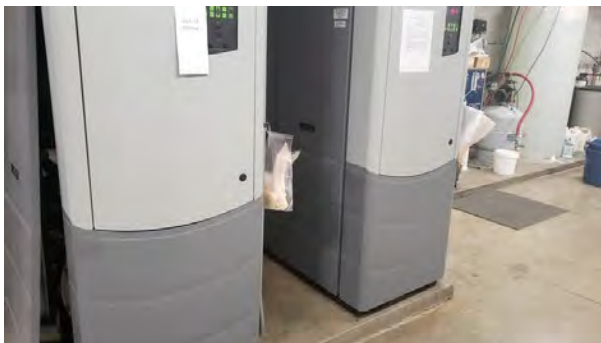
Heating boilers.

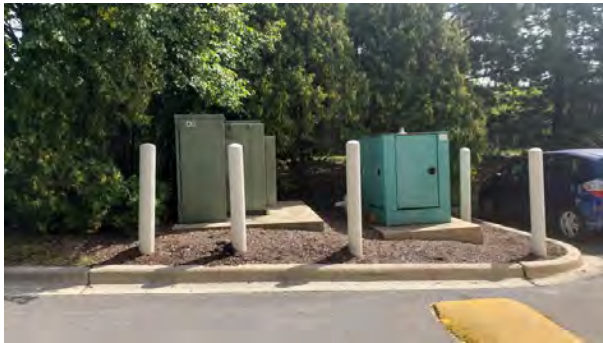
In general, the electrical systems for the Property, including switchboards, panel boards, lighting and wiring systems appeared in good condition and adequately sized for the intended use of the facilities. No material deficiencies were observed or reported. Routine maintenance is expected to be adequate to maintain the electrical systems in good condition during the projection period covered by this report.

Electical transformer at left.

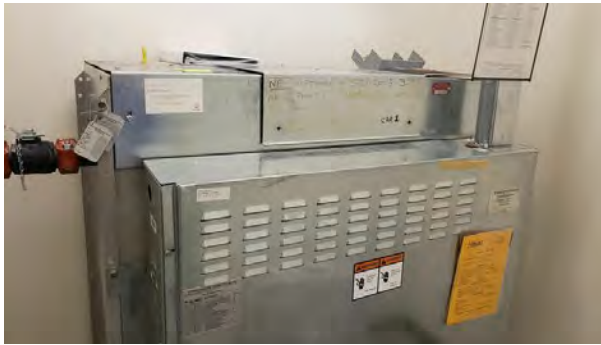
Hydraulic elevator equipment.

Based upon EUL, replacement of the passenger elevator cab interiors is anticipated during the projection period covered by this report. An opinion of cost for this work is included in the Tables.

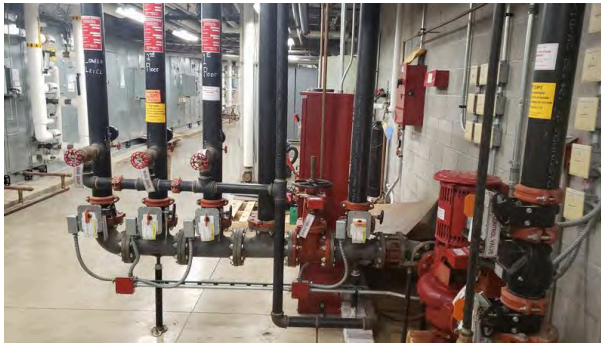
Routine maintenance is expected to be adequate to maintain the fire safety systems in good condition during the projection period covered by this report.

Fire protection risers.
