Facility Condition Assessment

Orland Park Public Library
14921 South Ravinia Avenue
Orland Park, Cook County, Illinois 60462

AEI Project No. 468087
Site Assessment Date: September 2, 2022

Subject: Facility Condition Assessment
Orland Park Public Library
14921 South Ravinia Avenue
Orland Park, Illinois 60462
AEI Project No. 468087

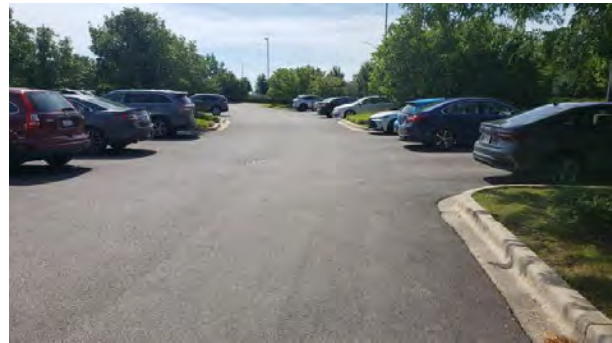
Asphalt paved parking and drive.

Cost Recommendation	EUL	EFF AGE	RUL	Year	Cost
Asphalt Pavement, Seal coat, Restripe, and Crack seal	5	4	1	1 6	\$25,600 \$25,600
Total					\$51,200

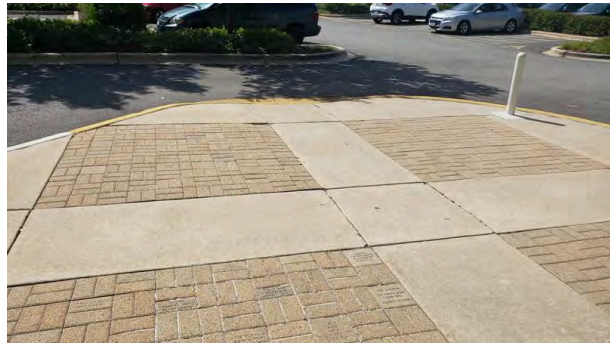
Concrete walks are provided throughout the site. Brick pavers are utilized between the concrete walkways at the entrance from the parking lot. The flatwork and brick pavers appeared to be generally in good condition. No significant problems or concerns were observed. Continued maintenance and repair are recommended as part of site operations.

Site-Pedestrian paving.

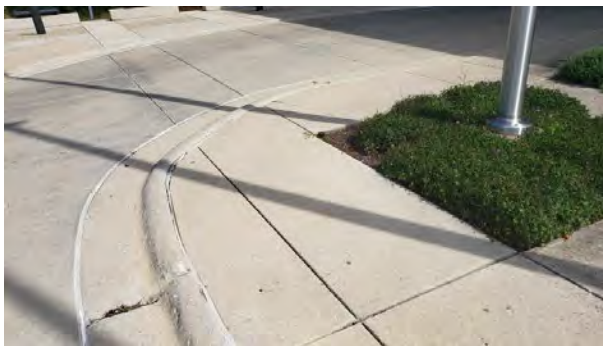
Concrete curbing was generally observed to be in good condition with no significant or obvious damage observed.

Concrete curbing.

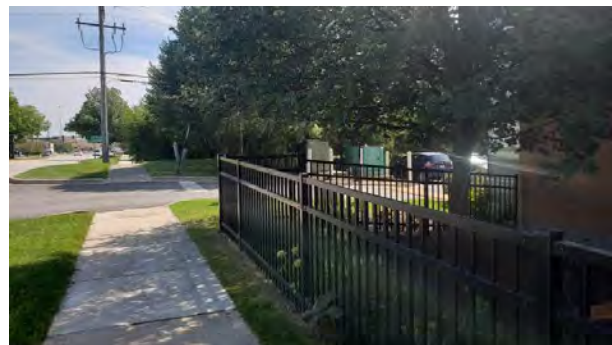
Perimeter fencing is provided along the north side children's outdoor activity area. The fencing is comprised of four feet tall decorative painted metal. The perimeter fencing was observed to be in good condition. Routine maintenance of the fencing, over the evaluation period, is expected to be generally sufficient to address to make repairs or to replace fencing components as necessary.

Perimeter fencing.

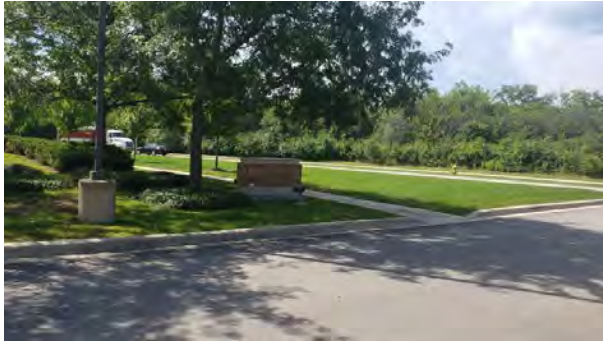
The Property and building signage was in good condition with no significant deficiencies. The remaining useful life of the signage is anticipated to exceed the evaluation period. Repair and repainting of the signage is considered to be a part of routine maintenance.

Site signage.

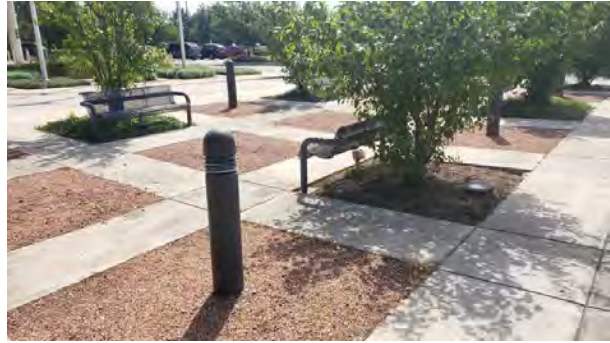
Lighting was observed to be in overall good condition. The quantity, location, and general intensity of the fixtures and lamps are considered to be generally adequate for the property. No unusual problems or concerns were observed or reported. Although not observed after dark, lighting appears adequate. The remaining useful life of the exterior lighting is expected to exceed the evaluation period. Due to the limited scope and low estimated cost, AEI anticipates that any repairs to the Property lighting can be accomplished as part of routine maintenance.

Pedestrian bollard light fixture.

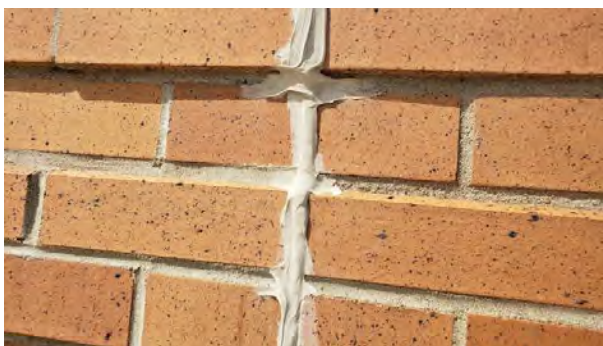
Control joint - poorly applied

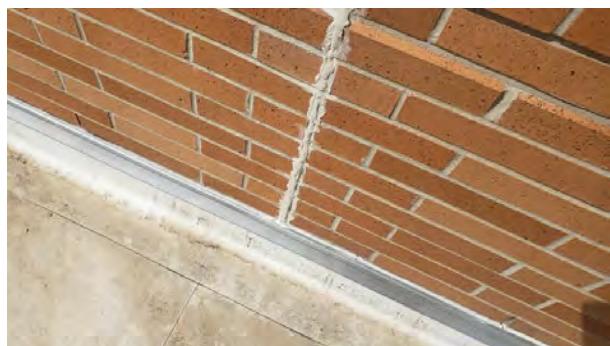
Control joint - poorly applied

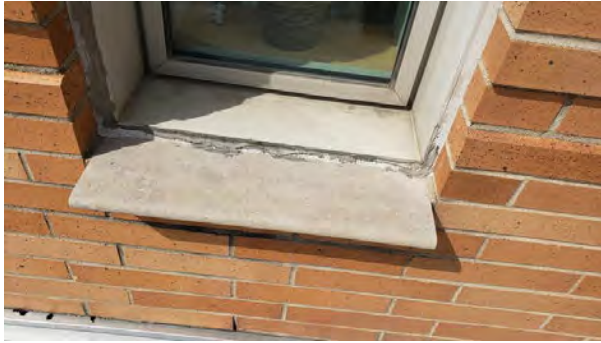
Caulking at window system

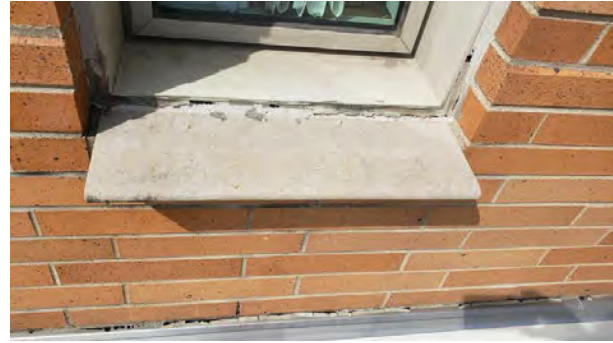
Caulking at window system
